**MAJOR REHABILITATION REPORT:  
MAIN REPORT and ENVIRONMENTAL ASSESSMENT**

**BOLIVAR DAM  
SANDY CREEK OF THE TUSCARAWAS RIVER, OHIO**

**PREPARED BY: USACE, HUNTINGTON DISTRICT**

**DRAFT REPORT FOR PUBLIC REVIEW – JULY 2008**

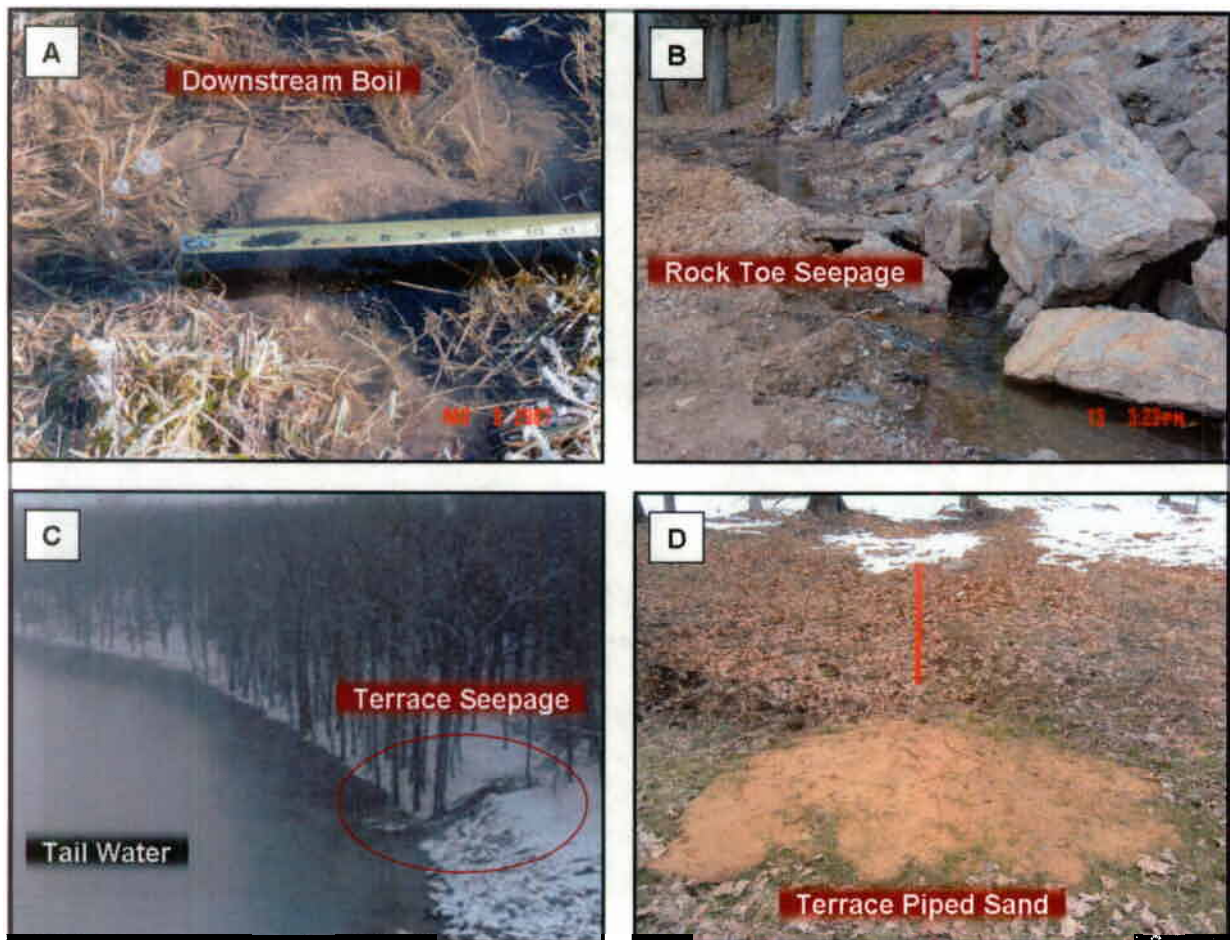
Bolivar Dam has a history of excessive uncontrolled downstream seepage ([Figure 6](#)) and the potential of through-seepage, underseepage, and slope instability at pools lower than spillway elevation. The Sandy Creek valley is a broad, deeply filled pre-glacial valley consisting of sorted glacial outwash materials with possible lenses of open work gravels. The glacial deposits, upon which the dam is founded are composed of pervious, fine to coarse gravelly sands, generally about 150 feet thick. Based on a review of the subsurface and instrumentation data, unsatisfactory performance of similar projects across the USACE inventory, and based on observed performance during the pool of record in 2005, it is believed that several areas of the embankment and/or foundation would become unstable due to piping at some pool less than the spillway crest level. This instability would threaten the integrity of the dam and could lead to a complete dam failure.

**Figure 6.** Photographs of seepage conditions. Near station 57+00, downstream area seeps and boils have been observed during events with <1-year return periods (A). Seepage at and above the rock toe has begun during events with a 3-year return period (B). During the record pool (94-year return period), excessive uncontrolled seepage exited the lower embankment and terrace slopes from stations 49+00 to 51+00 (C). Between stations 36+00 and 43+00, evidence of sand having been moved out of terrace deposits was apparent at the natural terrace slope toe during and after the record pool event (D).

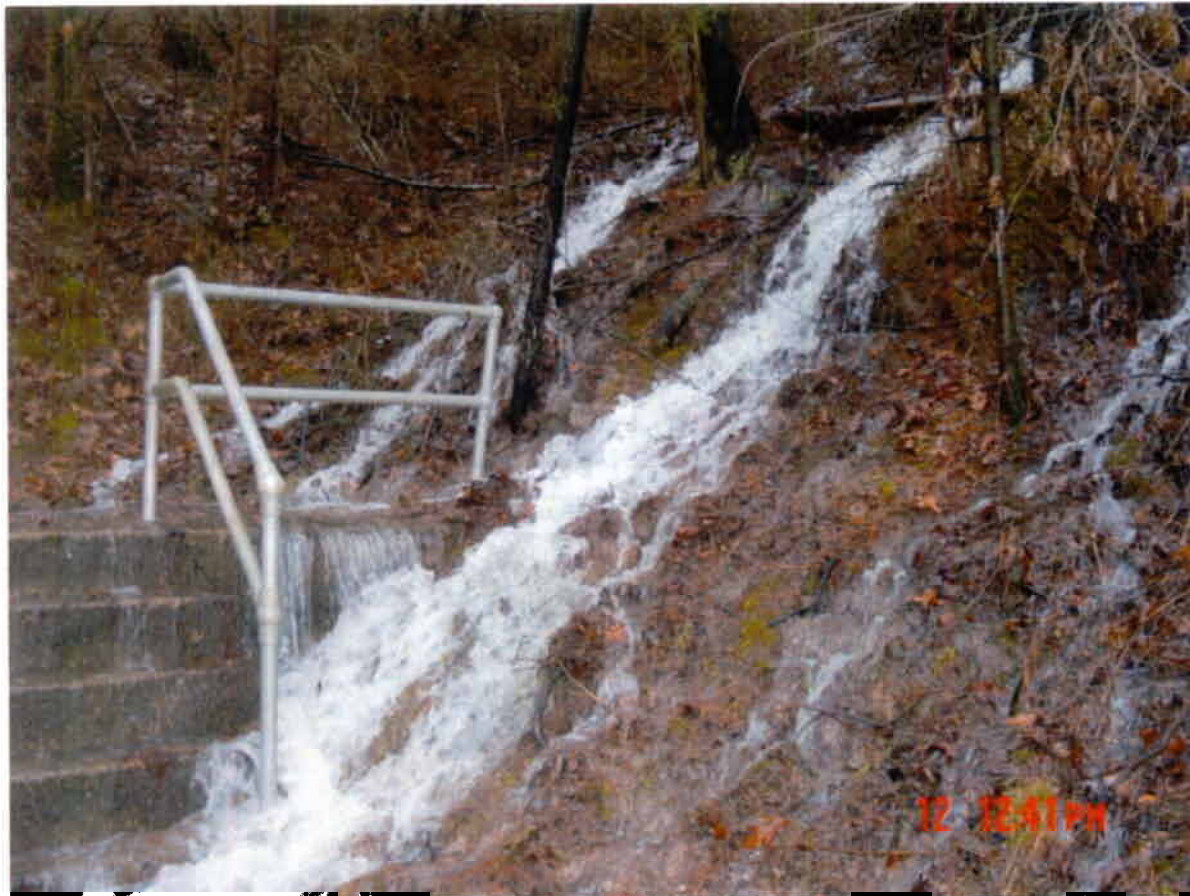
The left abutment was grouted during construction of the dam in 1937; however, significant seepage quantities (Figure 7) have historically begun exiting bedrock discontinuities at the cut slope of the outlet works at a pool elevation of 940 feet (10-year return period). The extent of the seepage path through the abutment bedrock cannot be verified; therefore, the future integrity of the abutment/embankment contact is in question. Rock seepage-related concerns at station 66+00 were addressed in this report through an expert elicitation process as part of Bolivar Dam's major rehabilitation study. See appendix for the details of this study.

**Figure 7.** Left abutment seepage during January 2005 record pool.

During the project's pool of record (Figure 8B) in January 2005 (elevation of 952 feet; 94-year return period), piezometric levels rose significantly and rapidly in response to increasing pool elevations, large relief well flows occurred, and numerous areas of uncontrolled seepage were observed. Contained in Appendix H, Plates B1 to B11, are photographs of the project which were taken during the event. Particularly near station 58+00, and in adjacent downstream regions, seeps beyond the seepage blanket produced large quantities of water with fine sand and silt being moved out of the ground. Heavy vegetation and the increasing tail water elevation prevented the monitoring of these regions during the entire event; submergence by tail water though could have somewhat improved stability against movement of material at these locations. Between stations 49+00 to 51+00, excessive uncontrolled seepage exited the lower part of the embankment and terrace slopes above the rock toe (Figure 6B). Based on the continued increase in seepage quantity and exit elevation during the event, a filter blanket (comprised of one foot of No. 57 river gravel overlain by one foot of No. 2 river gravel) was placed in this region as an interim emergency measure in an attempt to reduce risk. Evaluation of adjacent piezometric data trends versus pool elevation indicates that the initial causative pool for the conditions which prompted placement of this emergency filter was between 945 and 946 feet. After filter placement, the seepage quantity and exit elevation increased even further as the pool reached its maximum (Figure 6C). Between stations 36+00 and 43+00, pervasive seepage was observed at the toe of the natural terrace deposits, and evidence of sand having been moved out of the terrace deposits was apparent at the slope toe during and after the event (Figure 6D). At approximate pool elevation 944, project staff noted the seepage through the left abutment at four distinct locations. These seeps were approximately 50 feet from each other. Flow was exiting from the slope at the base of the lower limestone unit above the left side of the stilling basin. The estimated total flow of the seepages was approximately 150-200 gpm (Figure 7).

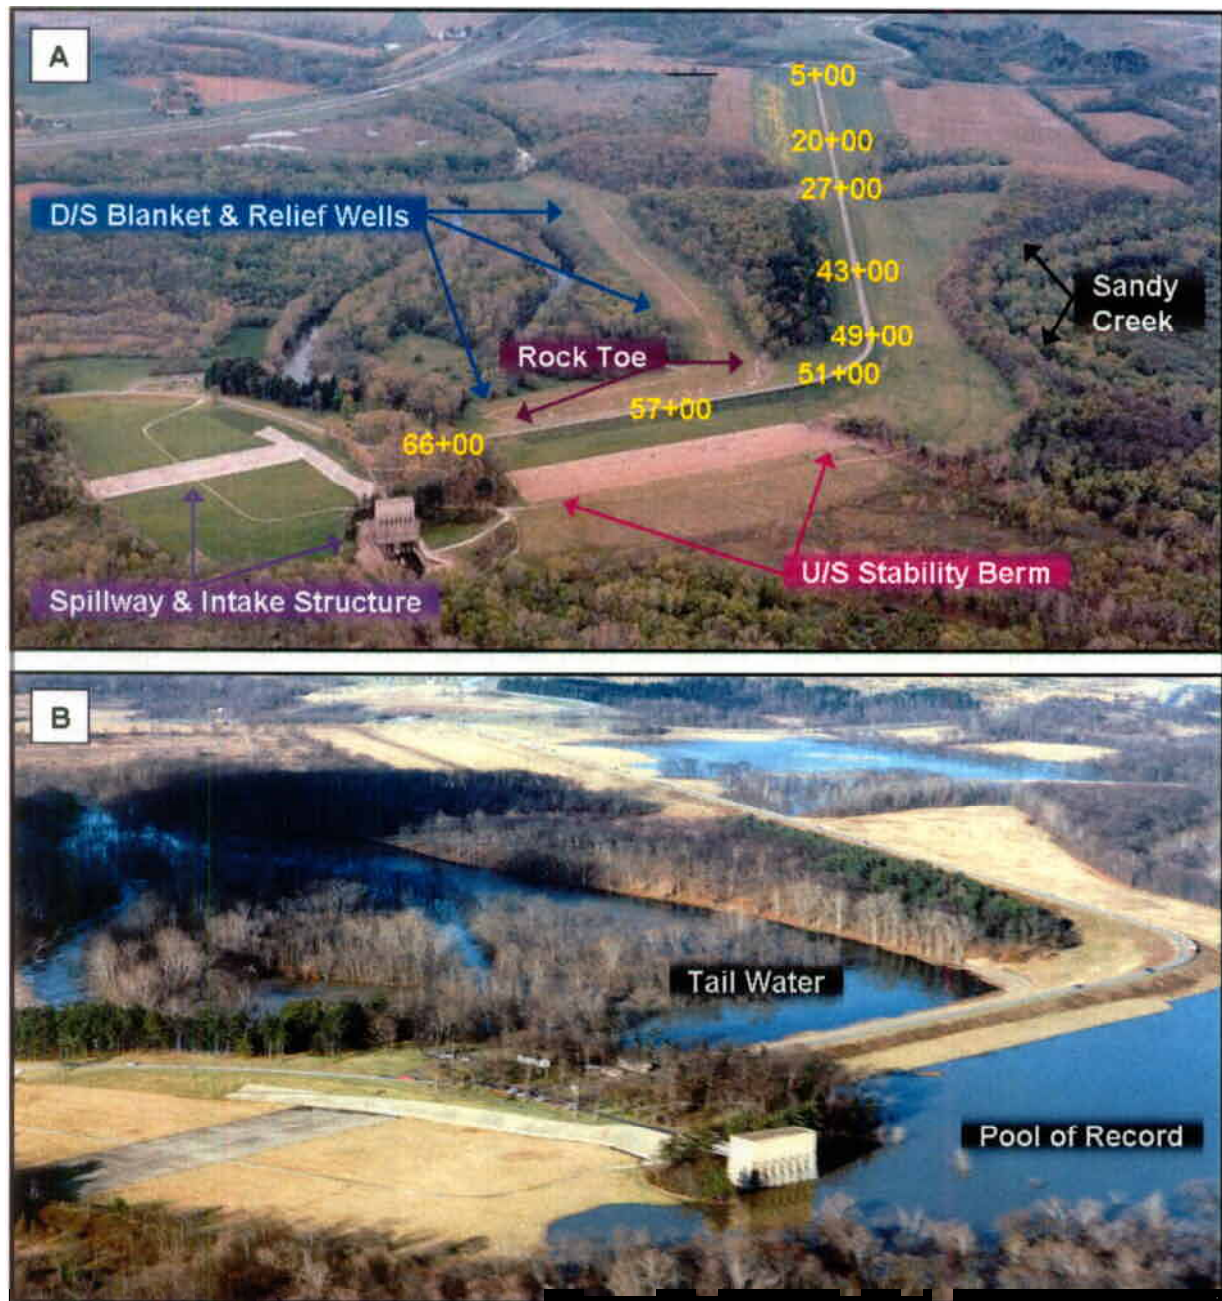
Shortcomings exist in the instrumentation for monitoring Bolivar Dam resulting from the downstream area being submerged beneath tail water during low-frequency events (Figure 8B). When the pool elevation is equal to or greater than 949 feet piezometric data have not been acquired, and may not be obtainable in the future at all downstream locations. Artesian flow above riser tops (not currently fitted with pressure gauges or other automated devices) has previously occurred during low-frequency events as well, and this has prevented data from being acquired throughout the events' duration. Relief well flow data cannot be acquired for this reason as well during low-frequency events. A second shortcoming of the relief wells is the likely potential for well performance to decline over time, coupled with the current lack of an implemented inspection, monitoring, and maintenance program. In general, wells suffer a loss in efficiency with time, for a variety of reasons such as clogging of screens and adjacent materials by fine particle infiltration, bacterial growth, and/or chemical incrustation.

**Figure 8.** Northward aerial view of Bolivar Dam during normal operation with no pool retained (A). Aerial view towards the northeast during the January 2005 record pool; pool = 952 ft, tail water = 906 ft (B).

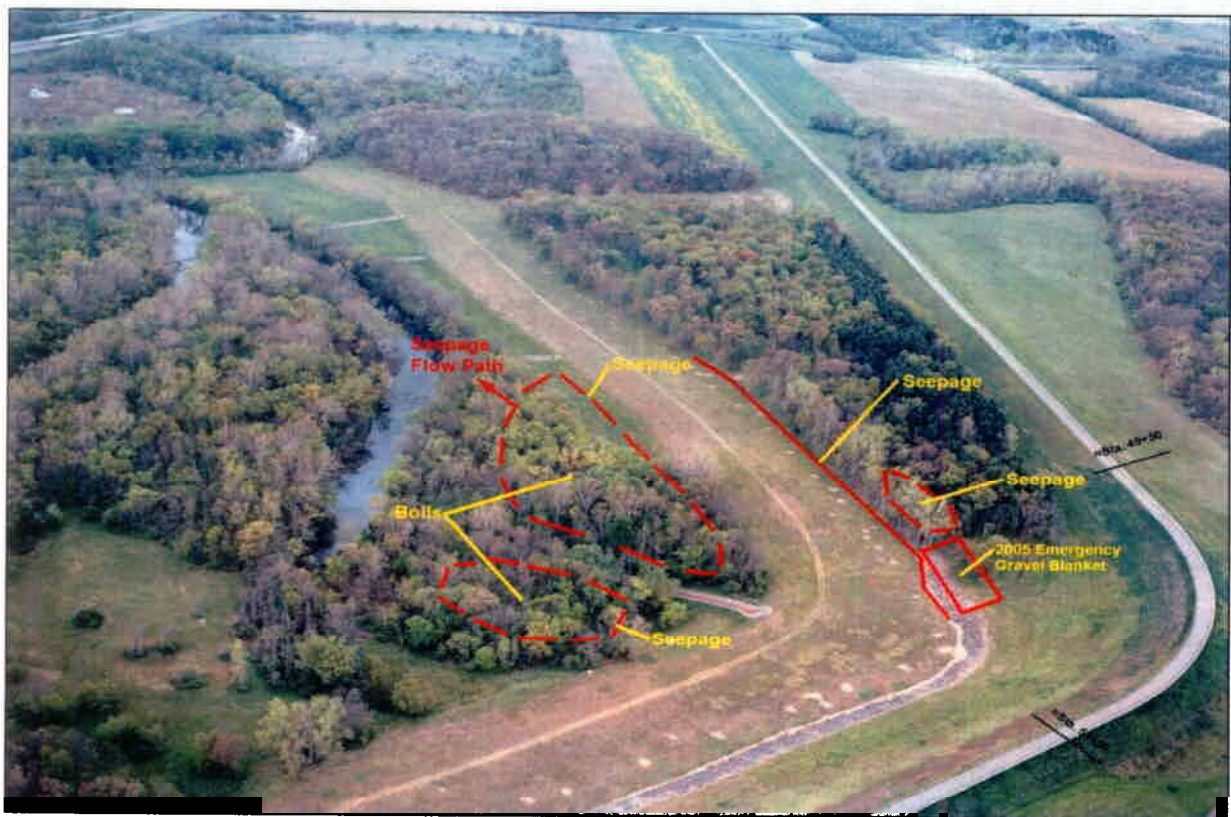
Historically, seepage (Figure 9) has exited the ground surface downstream of Bolivar Dam at pool elevations as low as 920 feet (<1-year return period). Seepage from the lower part of the embankment and natural terrace slopes above the rock toe has been observed to begin at a pool elevation of 930 feet (2.5-year return period); this is also the pool elevation at which flow from relief wells has first been observed. When the pool has risen above 930 feet, the quantity and exit elevation of seepage above the rock toe have both been observed to increase, and during the 2005 record pool (elevation of 952 feet; 94-year return period), excessive uncontrolled seepage exited the lower part of the embankment and terrace slopes above the rock toe between stations 49+00 and 51+00. The following paragraphs summarize observed performance of the dam during record events that the project has experienced.

**Figure 9.** Seepage areas downstream of the Bolivar Dam main embankment.
